START OF SEASON

BLOCKS, SHEAVES, MAINSHEET TRAVELER & GENOA CAR CHECKS

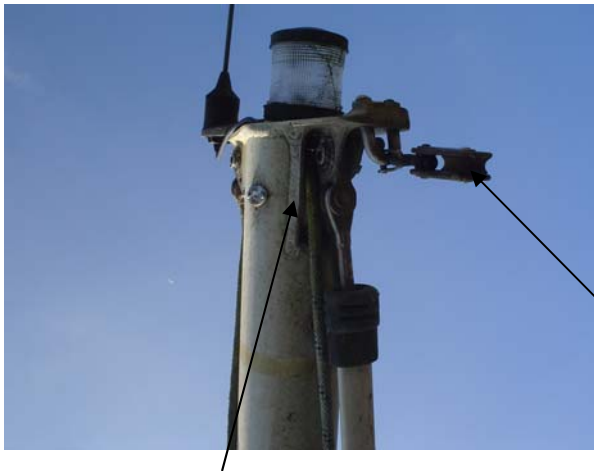
This masthead definitely needs some attention

Remove and inspect sheave

Replace this block

Check for excessive movement on the bearings of both blocks and sheaves, especially at the mast head. A broken mast sheave invites the halyard to jam itself at the worst possible moment with a trip aloft the only alternative to remove a sail. Barton carries a range of sheave sizes from 30mm up to 70mm diameter or you can contact your mast manufacturer for replacements. If you cannot get the exact same diameter, that's ok, as long as you make sure your replacement sheave is a tight fit width ways in the mast casing to prevent your mouseline jumping off the sheave and jamming.

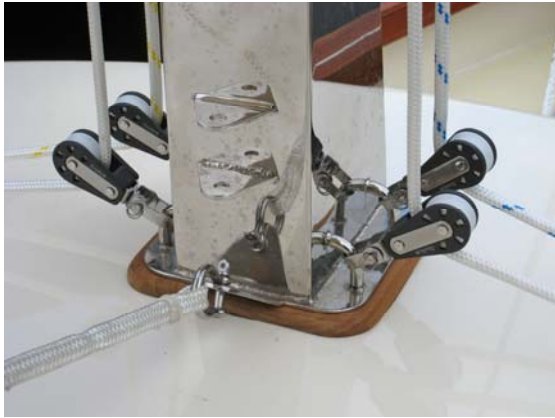
Plain bearing blocks fitted at the mast base

For ball bearing blocks, the sheaves should spin freely, again flush through with fresh water. Any grinding or uneven spin after flushing would suggest the block has been overloaded. Ball bearing blocks are not suitable for high static loads, such as round the mast base, replace with a plain bearing block or one with a higher rolling load rating

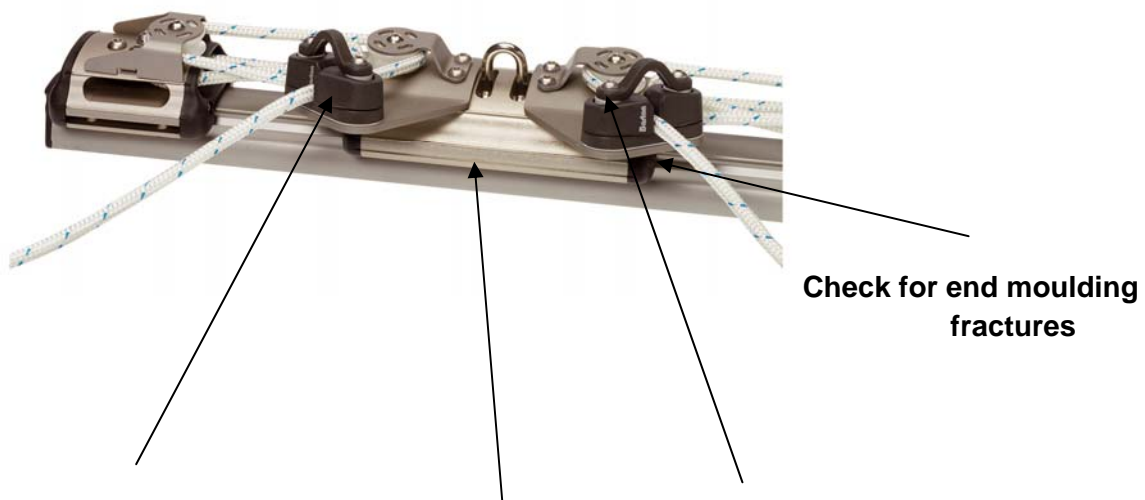
Flush Cam Cleats

Flush underside of traveller

Check for sheave damage

Check for end moulding fractures

Mainsheet traveller - Rinse thoroughly with a hose pipe and fresh water, especially the underbody where the ball bearings run in the car and along the track, again you can use a mild detergent solution for stubborn salt deposits, it will not harm the anodising. Take time to look at the end mouldings on the traveller car. Crash gybes are usually the cause of fractures, add spare end mouldings to your 'to do' list, you will need to remove the traveller car to do this so be sure to seek out or source a short length of track to transfer the traveller car onto for repair. Flush through your control line cam cleats with water under pressure, the cams should open and return freely, if not unscrew them and disassemble to check for broken return springs. Worn cam jaws reduce the efficiency of the cleat and will require a new replacement, go for the highest specification cleat you can afford for a longer life, we can recommend our K Cam series made from Kevlar and Zytel. Check also the condition of the control line sheaves, they are easy to remove and inspect, replacements may be required

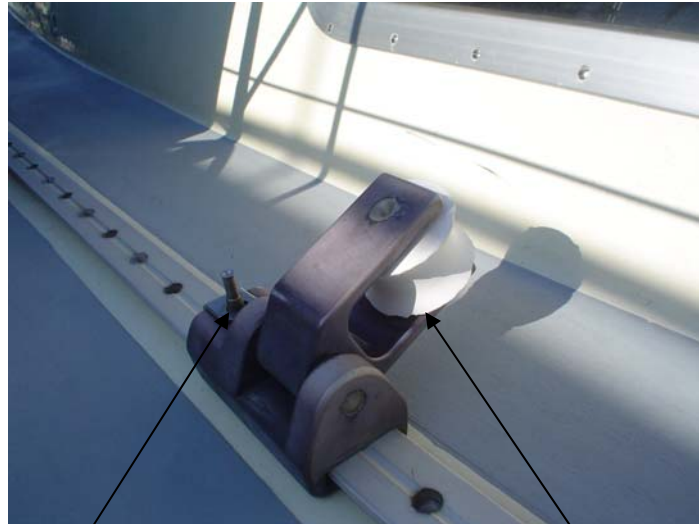
Broken pin needs replacing

Sheave damage will chafe sheets

Genoa Cars – Check for signs of excessive movement about the sheave bearing, a small amount of play is acceptable any more than this may cause the sheave to lock up under load, warning signs are excessive wear to one side of the sheave where it is not rotating. Sheaves can be replaced so long as the car has been regularly flushed through and looked after, heavy corrosion of the aluminium around the spindle makes it impossible to repair.
